NASA CR-159600
VOLUME 1 OF 2
AIRESEARCH 21-3213-1

MATERIALS FOR ADVANCED TURBINE ENGINES

PROJECT COMPLETION REPORT PROJECT 2

ABRADABLE COMPRESSOR AND TURBINE SEALS

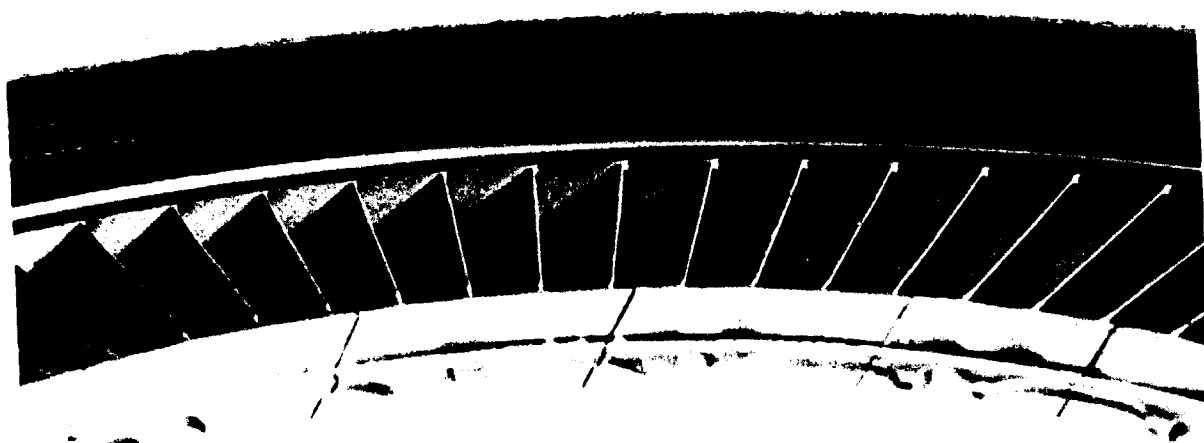
The Build 4 engine test produced blade contact throughout the entire shroud (360 degrees) to a maximum depth of 0.1016 mm (0.004 inch). Figure 85 shows the dual knife-edge rub near the deepest penetration. Figure 86 presents the SEM appearance of the

Figure 85. Appearance of Feltmetal 537 on the Second-
Stage Low-Pressure Turbine Shroud After 25
Hours of the Second Interim Engine Test,
Build 4 (Mag.: 1/2X)

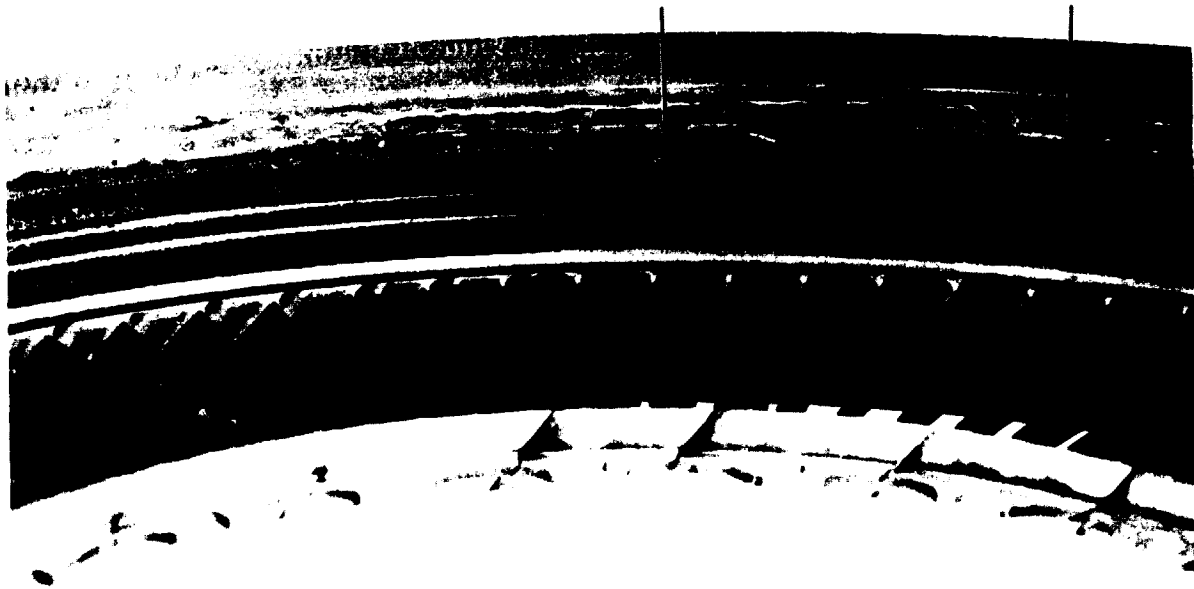
The engine test produced blade contact on the abrasable coating for the full 360 degrees of the shroud at depths ranging from 0.0508 to 0.2286 mm (0.002 to 0.009 inch). Figure 87 shows an inconsistency resulting from the test in that one of the presumably identical pieces of Feltmetal 535 exhibited severe gas erosion. Examination in the SEM of unrubbed areas in two adjacent shroud sections revealed an apparent difference in density as shown in Figure 88. Laboratory examination by the supplier indicated that the suspect segment contained regions of lower-tensile strength material that allowed the high-velocity gas to break down the structure.

Severe gas erosion on one segment

Figure 87. Appearance of Feltmetal 535 on the Third-Stage Low-Pressure Turbine Shroud After 25 Hours of the Second Interim Engine Test, Build 4 (Mag.: 1/2X)
